# Manhole Inspection Summary

Manhole # S69S\_\_008MH

Insp Date: **4/9/08 3:33 PM**

**Location** Address: **6600 Danville Ave.**

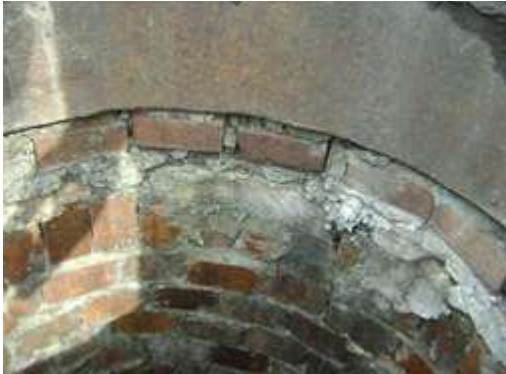
Defect 2

Infiltration: ☐ None ☐ Joint ☐ Cracks ☒ **Mortar** ☐ Roots ☐ Wall

infiltration of chimney frame through the mortar.

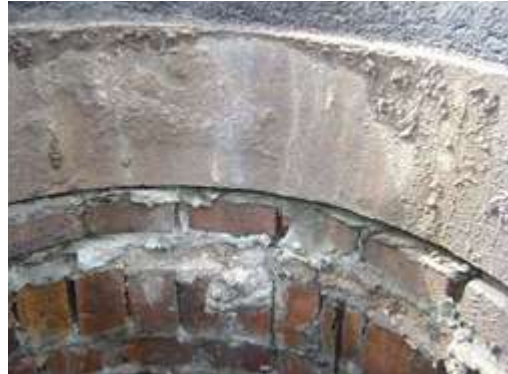
Defect 1

Condition: ☐ Sound ☐ Cracked ☐ Root Intrusion ☒ **Loose Brick** ☐ Deteriorated

loose bricks around chimney frame

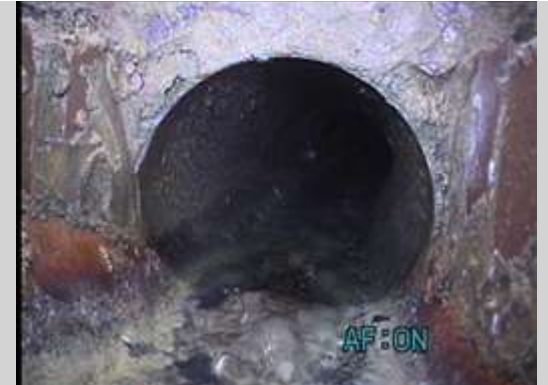
12 O'Clock Outflow

Pipe Height: **8.4** (in.) Rod and Bar (Angled)  
Pipe Material: **Clay** ☐ Pipe Lined  
Invert Depth: **9.58** (ft.) Flow Characteristics: **Fast**  
Deposits: ☒ None ☐ Mud ☐ Sludge ☐ Debris ☐ Grease  
Silt Depth: (in.) Deposits Extent:  
Infiltration: **None** Pipe Seal Cond: **Sound**

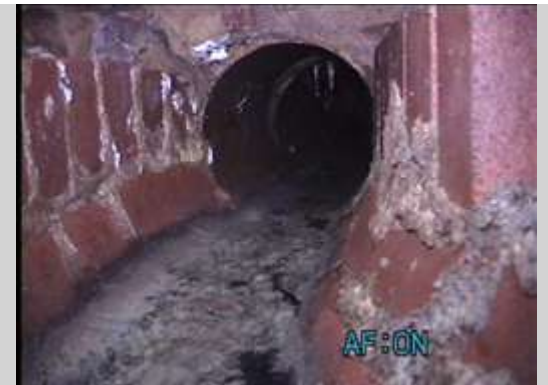
6 O'Clock Inflow

Pipe Height: **8.4** (in.) Rod and Bar (Angled)  
Pipe Material: **Clay** ☐ Pipe Lined  
Invert Depth: **9.42** (ft.) Flow Characteristics: **Fast**  
Deposits: ☒ None ☐ Mud ☐ Sludge ☐ Debris ☐ Grease  
Silt Depth: (in.) Deposits Extent:  
Infiltration: **None** Pipe Seal Cond: **Sound**

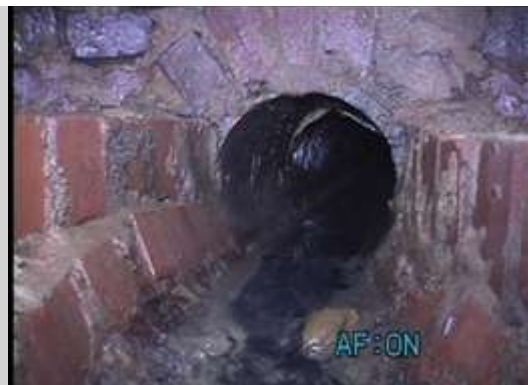
9 O'Clock Inflow

Invert Depth: **9.33** (ft.) Flow Characteristics: **Slow**

Infiltration: **None**

Pipe Seal Cond: **Sound**
